**CRAFS® - CONTROL OUTLET**  
**USED AS CHECK DAM & INLET SEDIMENT TRAP**  
Heartis Senior Living - 936 W Linear Ave - Fayetteville, GA 30214  
May, 2017

////////////////////////////////////  
***CRAFS® - The Corrugated Retention and Filtration System for Sediment Control in  
Critical Spots with Trouble Conditions where Silt Fences Fail***  
////////////////////////////////////

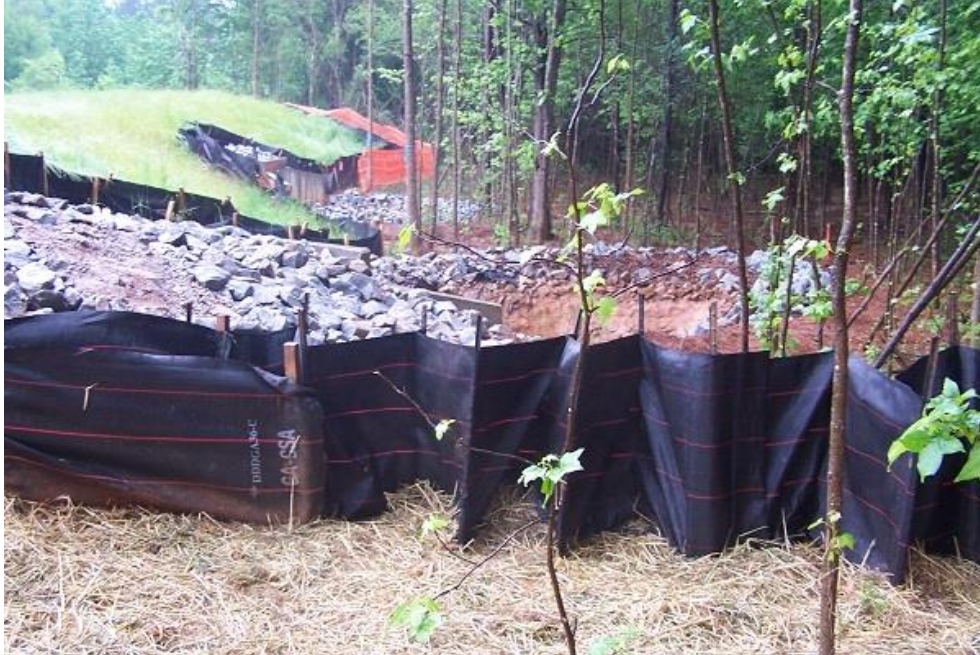
PHOTO 1 : CRAFS® upstream of catch basin after first rainfall event  
... both installed the day before the rain ([Photo ID: 100\\_0401 LoPix](#))

The installation is located at the "toe-of-slope" upstream from a runoff retention basin that was constructed to collect excess runoff from the much larger sediment pond atop the slope that collected a major portion runoff from the entire project site. The CRAFS® was installed as a "check dam" to intercept runoff around the project perimeter upstream of a retention basin at low spot at the property boundary. (See Photos 1 & 2)

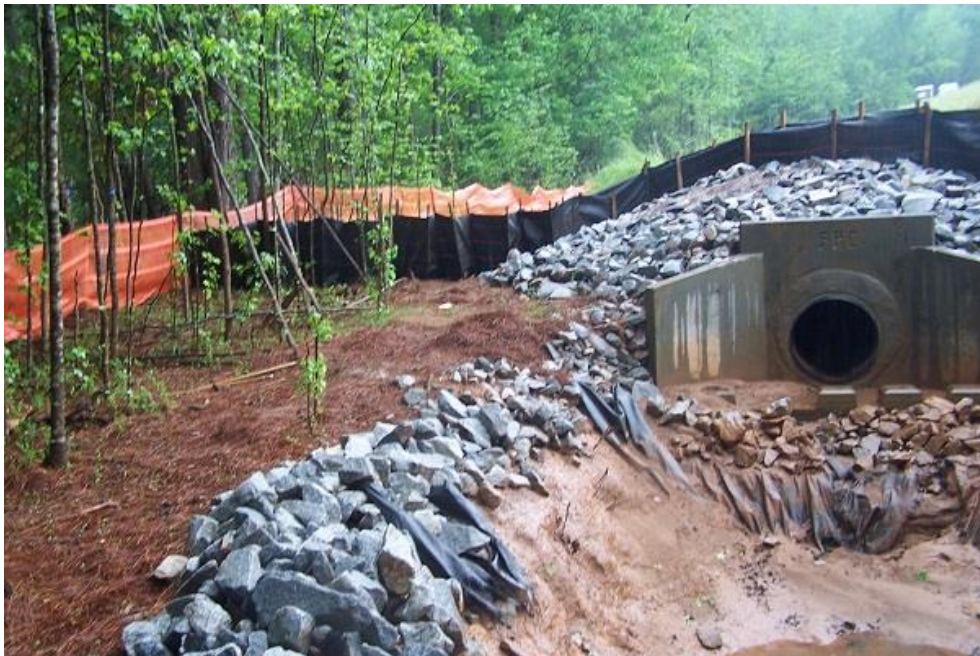
PHOTO 2 : View of CRAFS® looking upstream from catch basin ([Photo ID: 100\\_0403 LoPix](#))

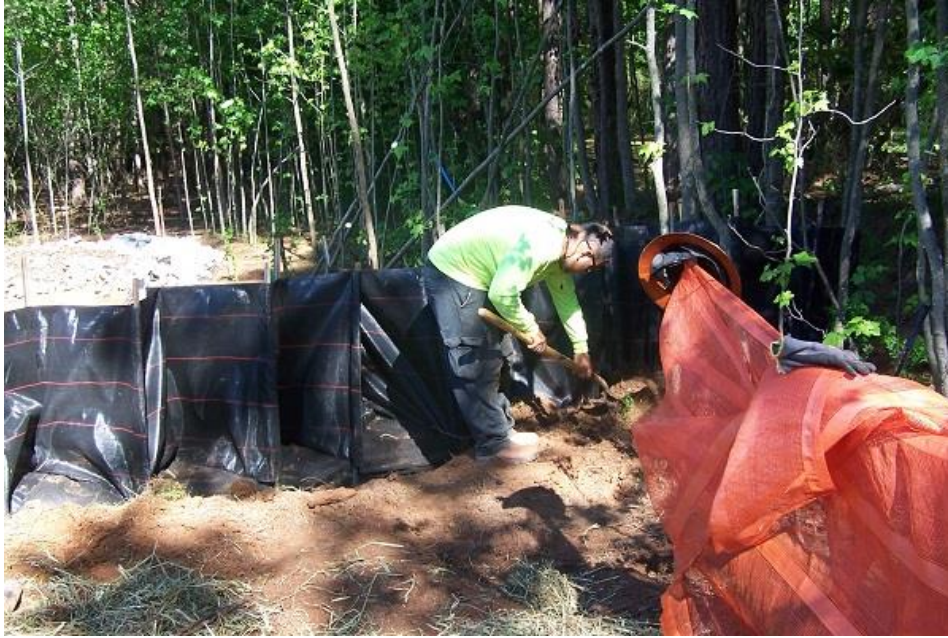
PHOTO 3 : CRAFS® installed across runoff flow path upstream of catch basin (5-2-17) ([Photo ID:100-0381LoPix](#))

CRAFS® was installed the first week of May, 2017 (See Photo 3). Multiple rainfall events occurred within the days immediately following its installation.

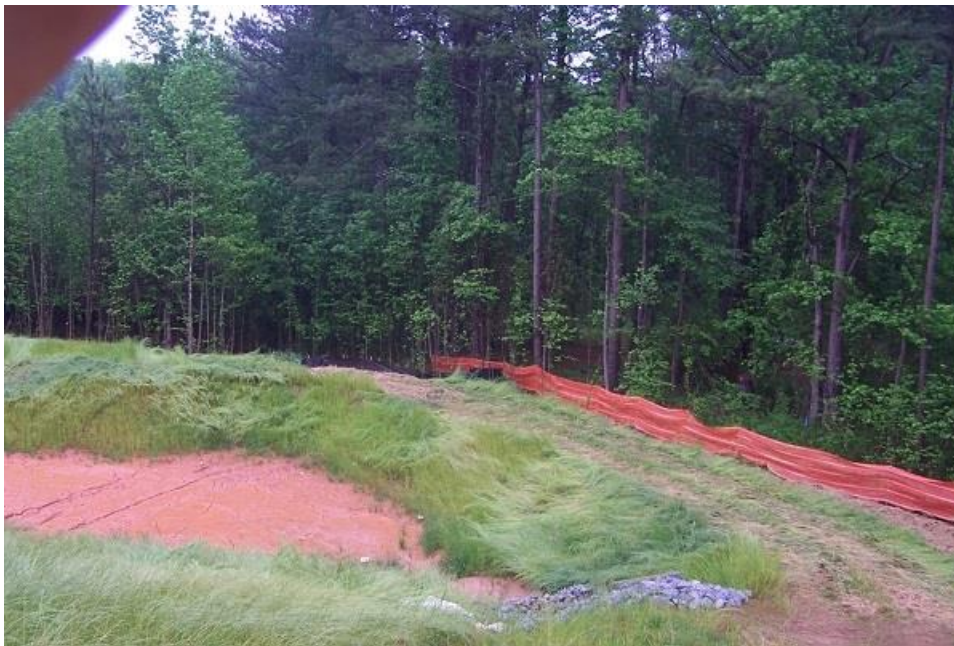
PHOTO 4 : Distant view of CRAFS® at toe of 3:1 fill slope in runoff flow path from the project's perimeter. ([Photo ID:100-0390 LoPix](#))

A quick glance from atop the slope above the "CRAFS® Check Dam" one month after installation reveals nothing but the system being intact, as originally installed. There is no obvious runoff held within the retention wedges of the structure, despite the multiple heavy rainfall events. Several of these were 1" per hour or greater. (See PHOTOS 4)

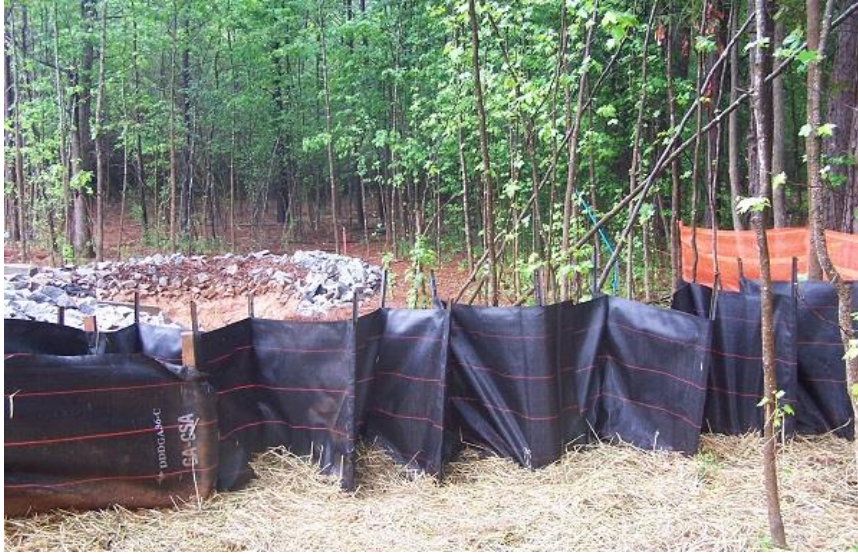
PHOTO 5 :  
Closer view shows CRAFS® system “in place” and stable after rainfall even  
Note the height of sediment deposits against adjacent silt fence fabric left of  
CRAFS®. Filtered seepage through CRAFS® is rapid, so sediment markings  
on CRAFS® filter fabric are low and hidden by the straw ground cover that’s  
washed against the retention wedges.  
(Photo ID: 100-0399 LoPix)

Photo 5 shows a closer view of the CRAFS® Check Dam-Inlet Sediment Trap that confirms the system's stability. Two weeks later after several more rainfall events, Photos 6 shows the build up of retained sediments against the CRAFS® filter fabric at the system's downstream vertexes. National Weather Service (<http://water.weather.gov/precip/>) reports 6" accumulated rainfall for the area since that installation.

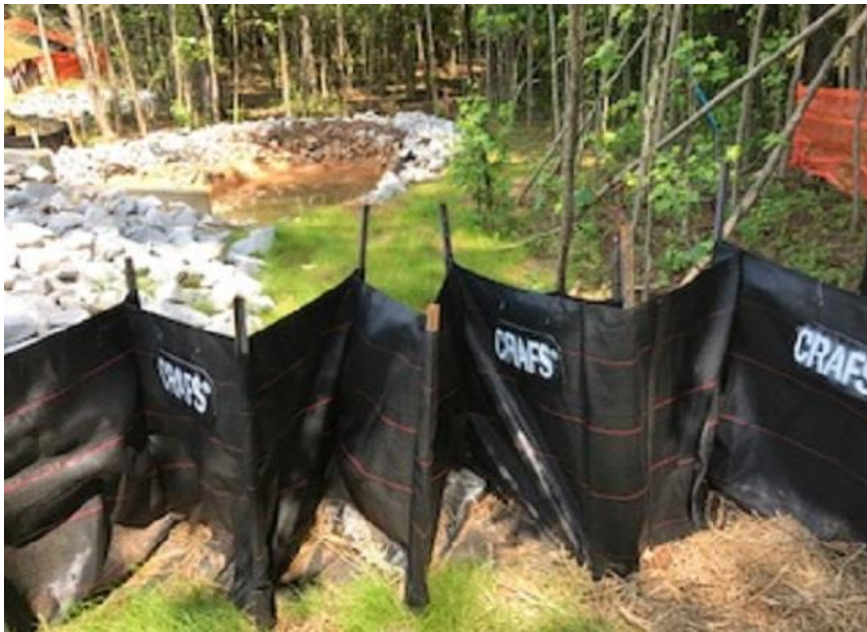
PHOTO 6 :  
Retained sediments are obvious within the CRAFS® “retention wedges”  
after one month in place and 6” rainfall accumulation. Note clarity of water  
in sediment pond downstream of CRAFS®. Rainfall per U.S. Weather Service.  
(6-2-17 Photo ID IMG-0023 LoPix)

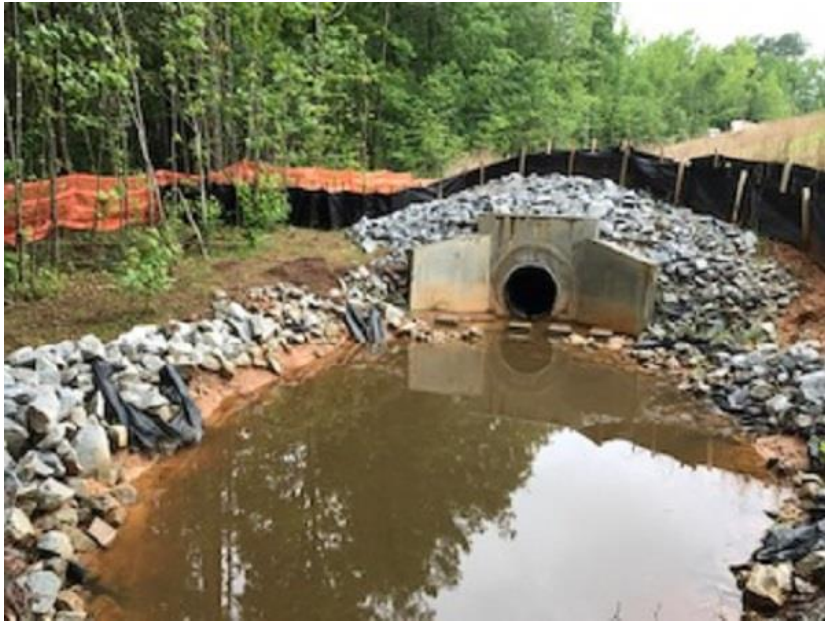
PHOTO 7  
CRAFS® installed upstream of the retention pond to provide sediment retention and filtration before runoff enters the pond. Note the low turbidity level in pond maintained by CRAFS® upstream. (6-22-17) (IMG 0144 - LoPix)

Photo 7 shows CRAFS® installed upstream of the collection pond for sediment retention and filtration that cleans the runoff before it enters the pond. Note the low turbidity level in pond with the upstream protection provided by CRAFS®.

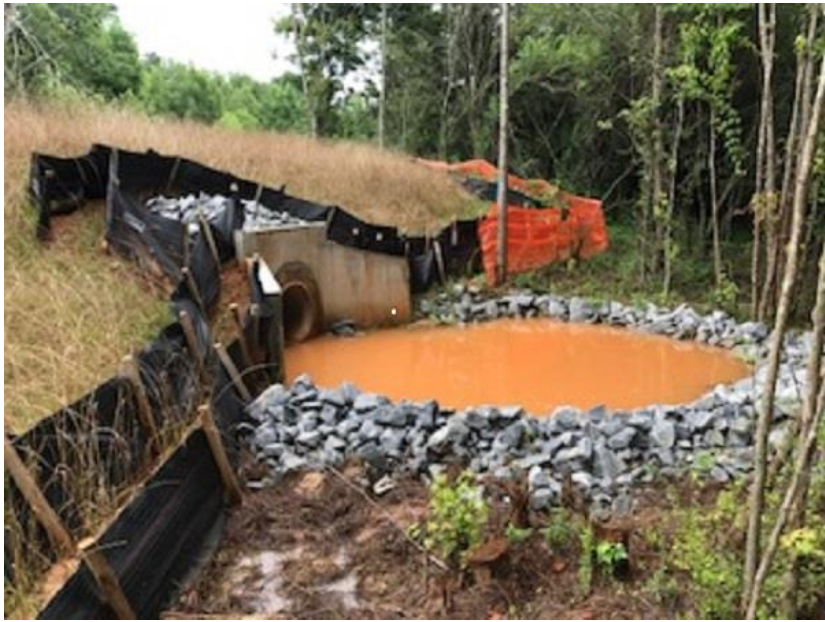
PHOTO 8  
Second retention pond at same elevation and toe of same slope 150' away from CRAFS® protected pond (shown in PHOTO 7). (6-22-17) (IMG 0141 - LoPix)

Photo 8 shows a second collection pond at same elevation and toe of same slope 150' away from the protected pond shown in PHOTO 7. Note the difference in turbidity levels of photos taken same day.
